FOCUSED SITE INSPECTION PRIORITIZATION SITE EVALUATION REPORT

NATIONAL DSPL #1 2424 W. CLARKE STREET PEORIA, ILLINOIS

CERCLIS ID NO.: ILD980901581

Date Prepared: September 28, 1995

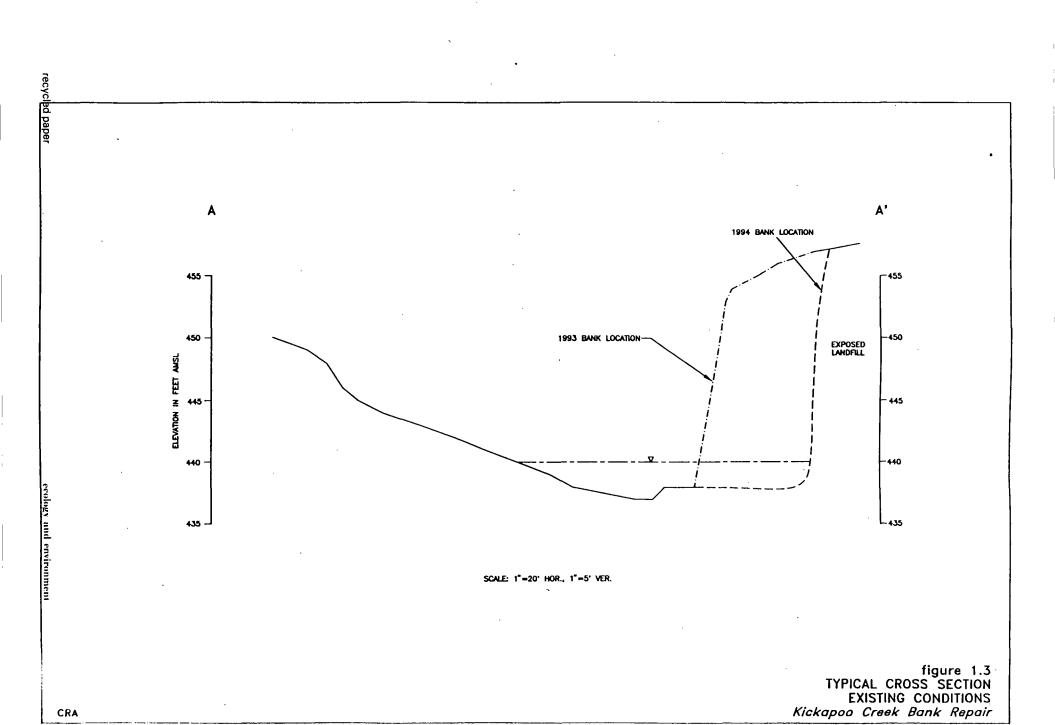
figure 1.2 1993 SITE CONDITIONS Kickapoo Creek Bank Repair

By 1993, the hydraulic situation resulted in sufficient erosion of the stream bank to expose waste that had been buried during the operation of the landfill. A repair of the bank was proposed by the previous landfill operator and the affected landowners. Before repair could be performed, the extended flood period of 1993 occurred. During this extended period of high flows, the stream has eroded an additional 30 feet into the bank of the outside of the bend and the landfill. Figures 1.2 and 1.3 show the topography in the spring of 1993 and a typical cross-section of Kickapoo Creek at the most extreme exposed portion of the landfill. Figure 1.2 also shows the location of the stream bank in 1994 after the flooding.

The purpose of this detailed design report is to present a proposed repair to the landfill cover and adjacent stream bank that will provide long-term protection from erosion.

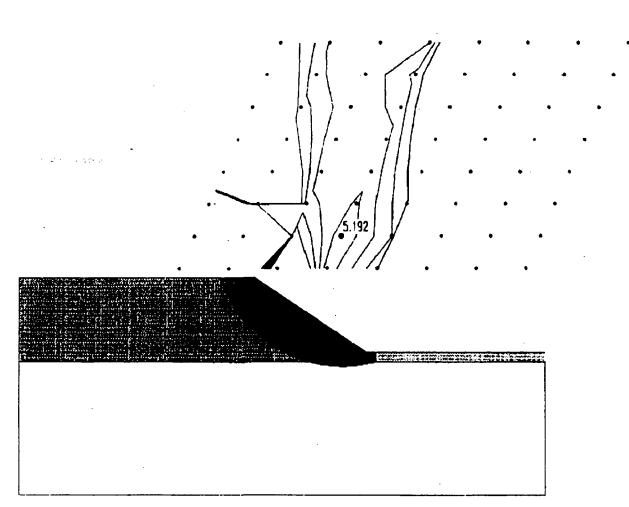
Kickapoo Creek Bank Repair - Slope Stability Analysis

A slope stability analysis has been conducted for the proposed repair. This analysis indicated a Factor of Safety of between 4.6 and

5.1 against rotational failure for this degree of slope. A copy of the slope stability analysis is contained in Appendix A.
